PHASE I INSPECTION REPORT
NATIONAL DAM SAFETY PROGRAM

UPPER VALLE MINES DAM
Jefferson County, Missouri
Missouri Inventory No. 30370

Phase I Inspection Report
National Dam Safety Program

Name of Dam	Upper Valle Mines Dam
State Located	Missouri
County Located	Jefferson
Stream	Unnamed Tributary of Joachim Creek
Date of Inspection	15 August 1980

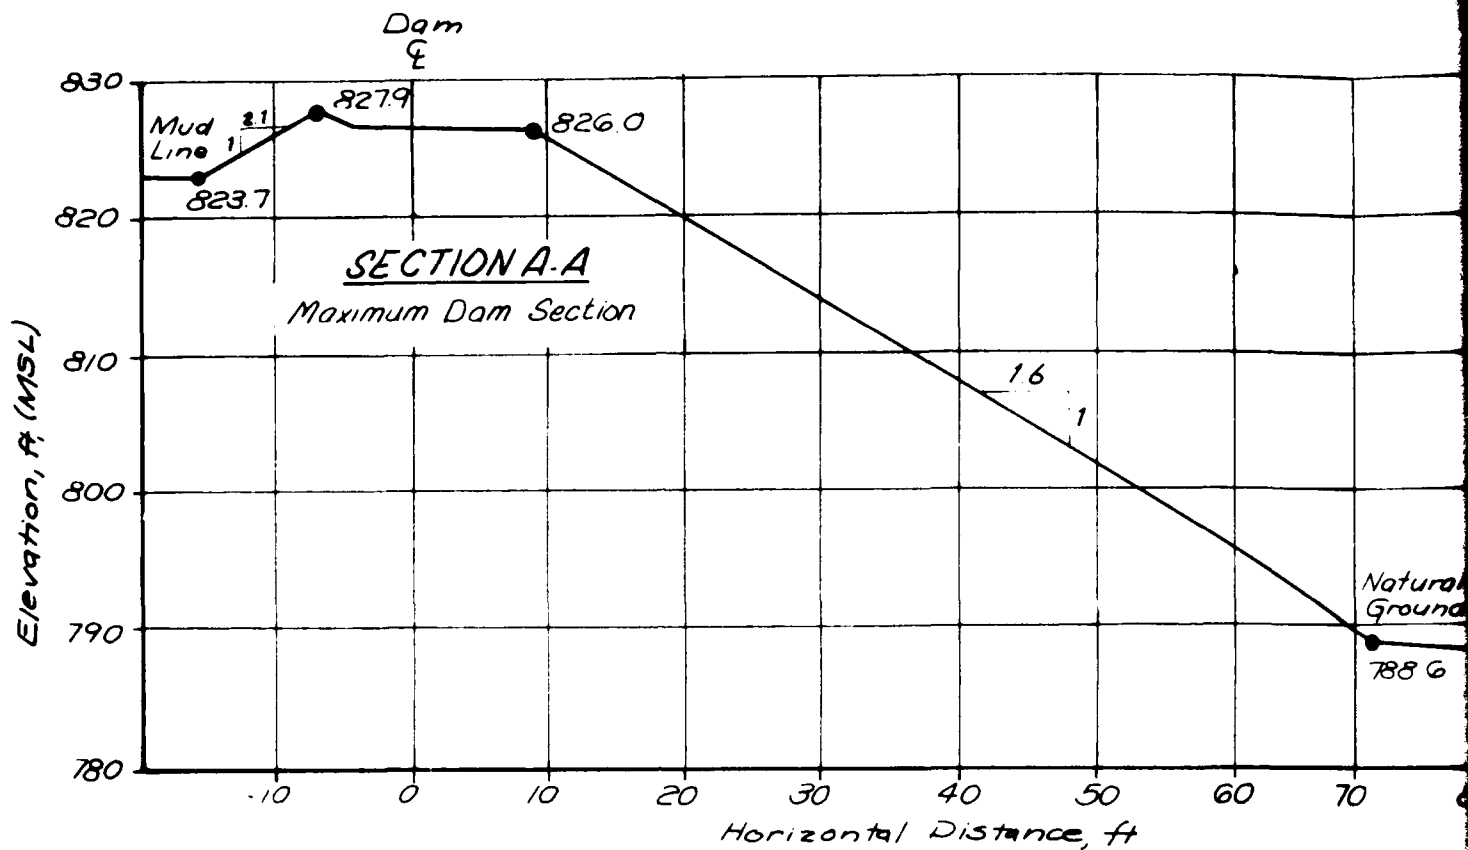
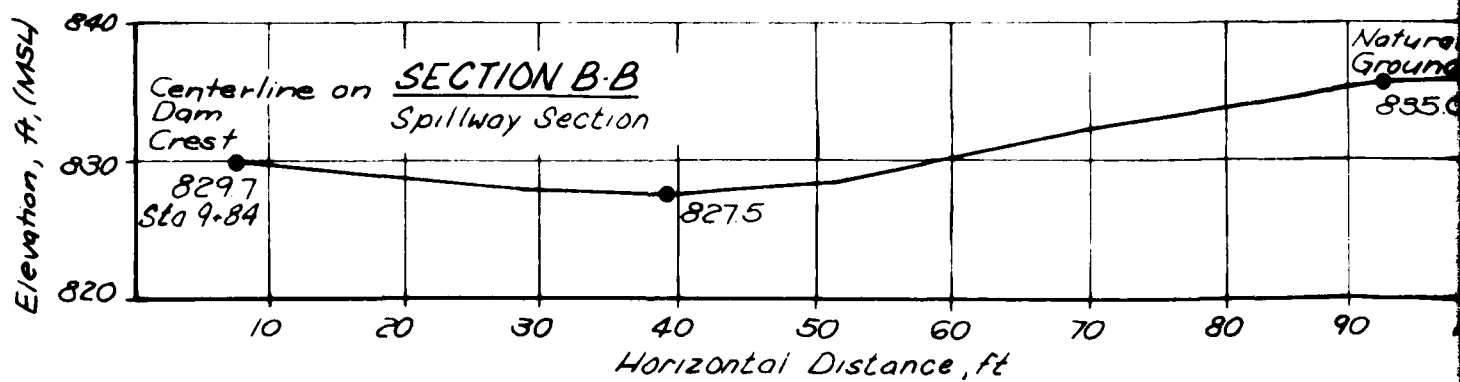
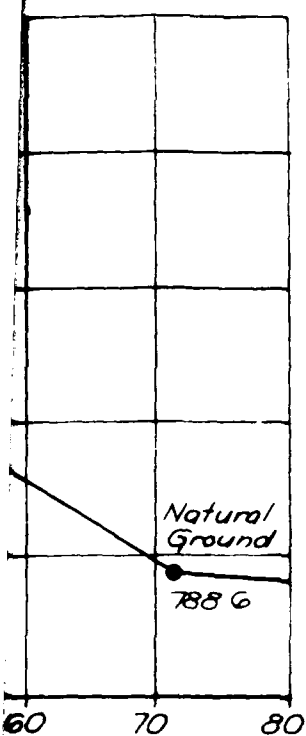
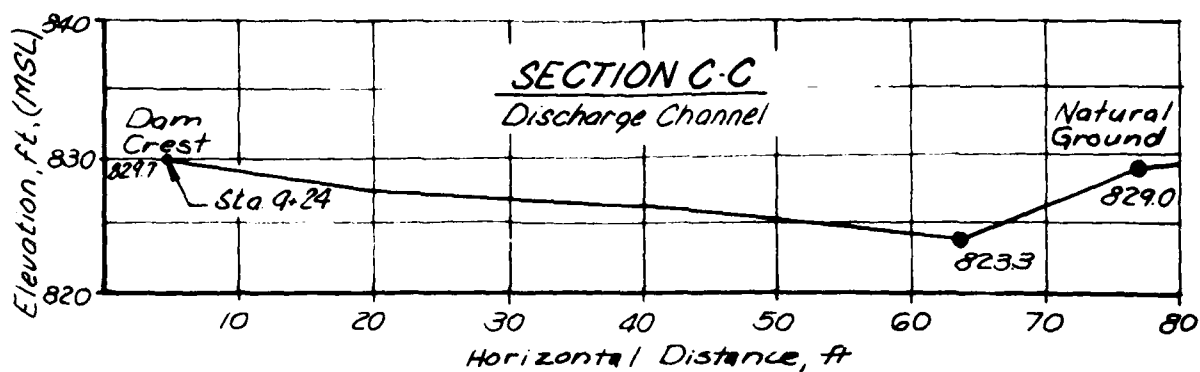
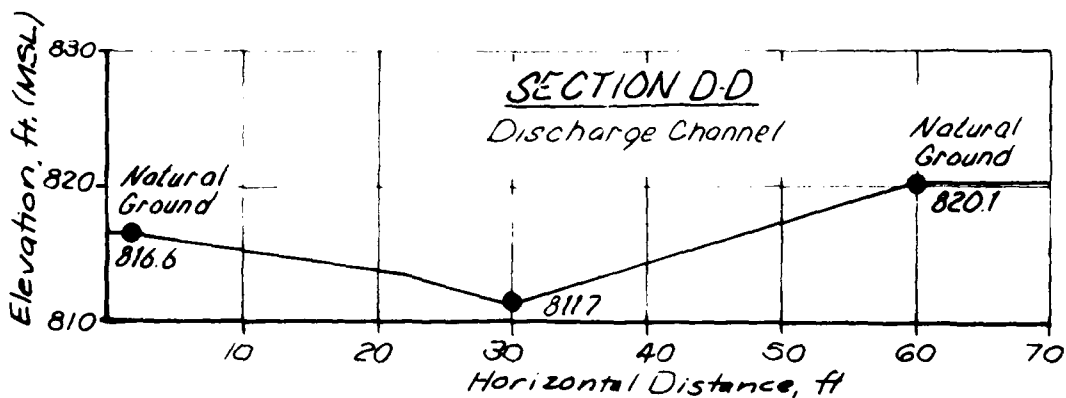
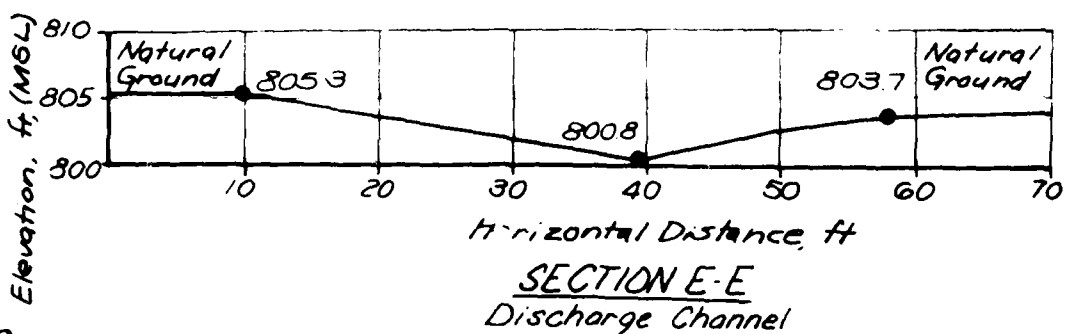
Fig. 3-B

*Chat piled along upstream edge of dam is typically 1 to 3 ft higher than centerline of dam (see Fig 3B, Maximum Section). For overtopping analyses the low point along the crest was taken at elevation 827.7.

The downstream face of the dam is quite steep, averaging approximately 1.6(H) to 1(V), (Fig 3B). Portions of the slope with a mantle of bullrock cobbles and boulders, are as steep as 1(H) to 1(V), (Photo 3). The exposed portion of the upstream slope is slightly flatter at about 2.1(H) to 1(V). Erosion protection is provided for by the vegetation present on the dam. The potential for erosion is low on the upstream face due to the presence of the vegetation and the short fetch of the reservoir.
